Vehicles Travelling Up the Eastbound A50 exit Slip

There have been an increased number of reports of vehicles travelling up the A50 Junction 5 eastbound exit slip road towards Hilton. Appendix 1 and 2 show images taken from dashcam footage on 23/02/24 and 27/03/24. Both images show a vehicle proceeding up the slip road. This is a dangerous occurrence and Hilton Parish Council is therefore concerned that an accident may occur. In the case of the footage of 23/02/24 it appears that the vehicle approaches the slip road from the Etwall direction and turns left up the slip road.

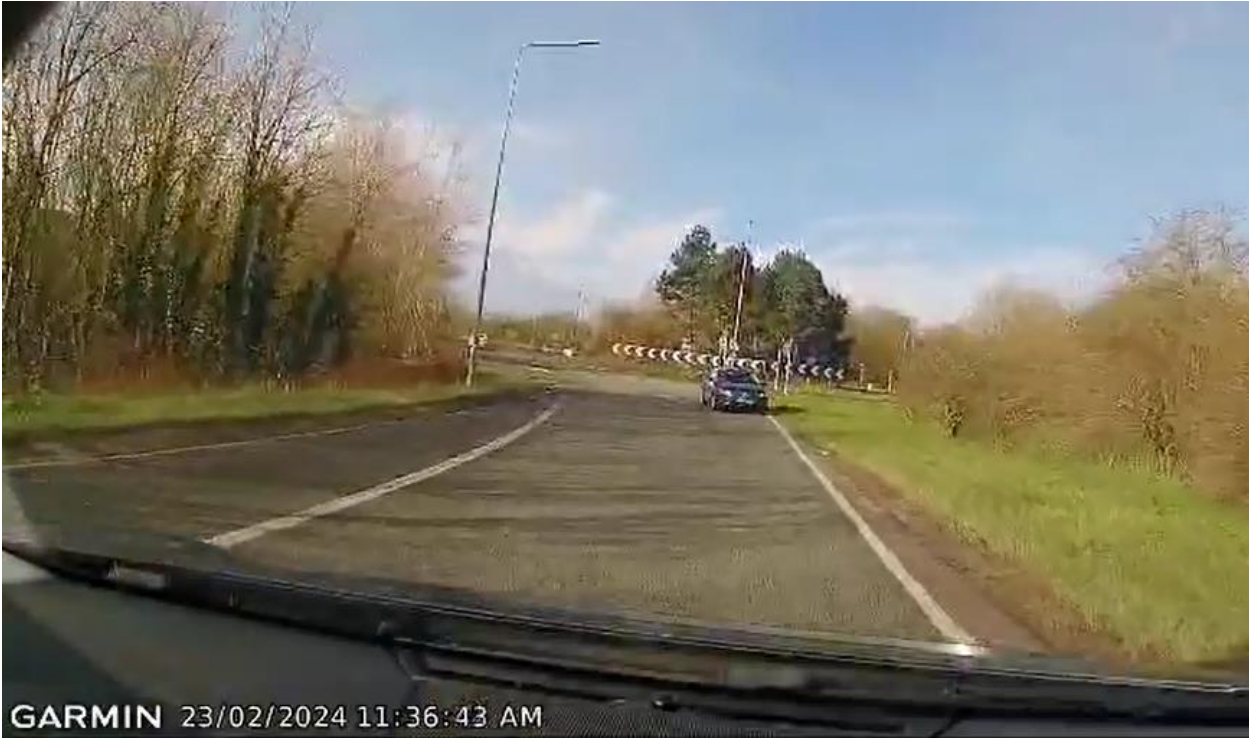
Appendix 1 - Image from Dashcam showing vehicle travelling up the slip road on 23/02/24

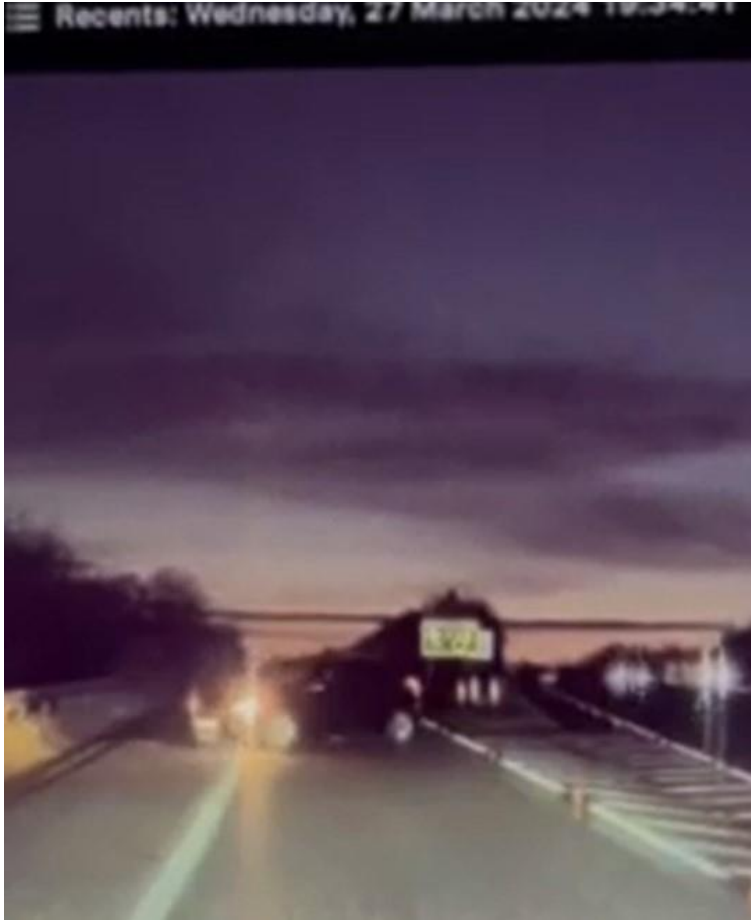
Appendix 2 - Image from Dashcam showing vehicle turning after travelling up the slip road on 27/03/24

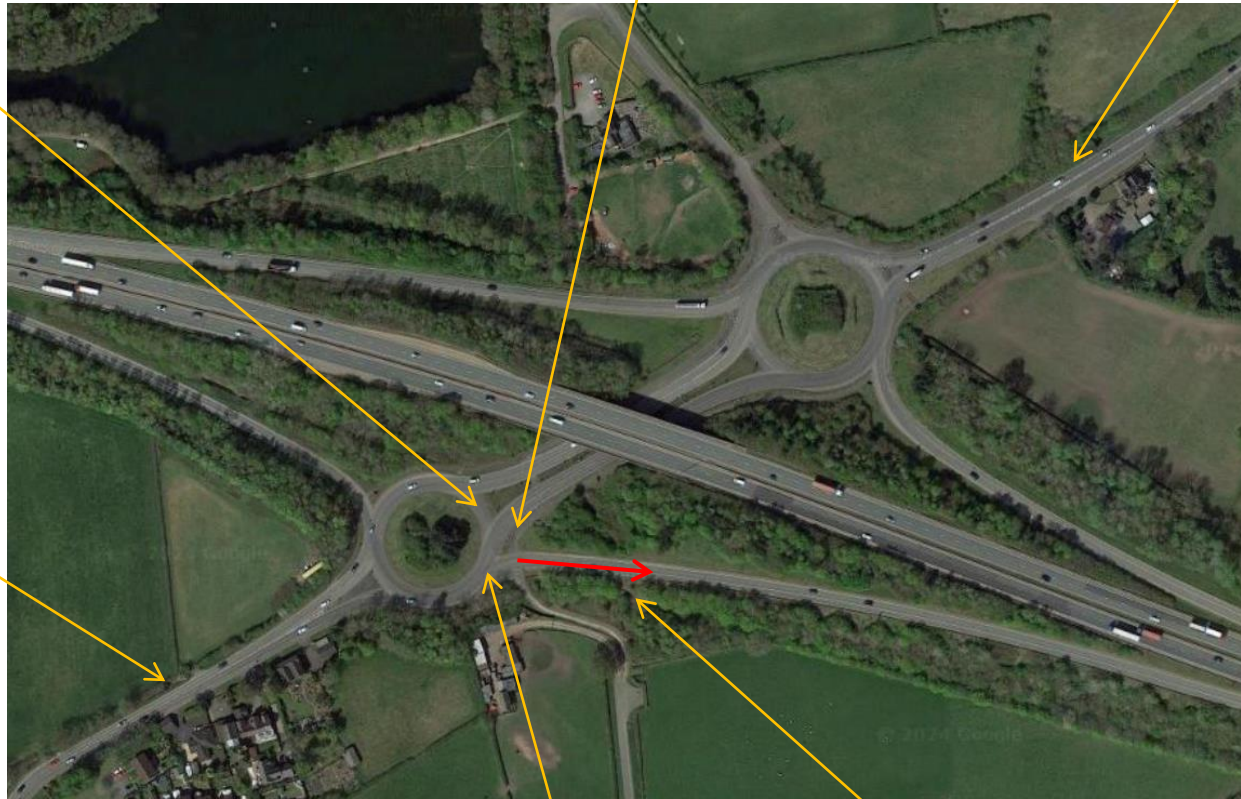
Appendix 3 – Layout of the Junction

The junction provides the link between the A516, A5132 and the A50 and is configured as 2 separate but joined roundabouts below the A50. Graded slip roads link the roundabouts to the A50 in both the east and west directions. Appendix 3 shows the layout of the junction, the red arrow shows where vehicles are travelling up the slip road. The slip roads have a speed limit of 70mph.

Vehicles have been travelling Up this slip road

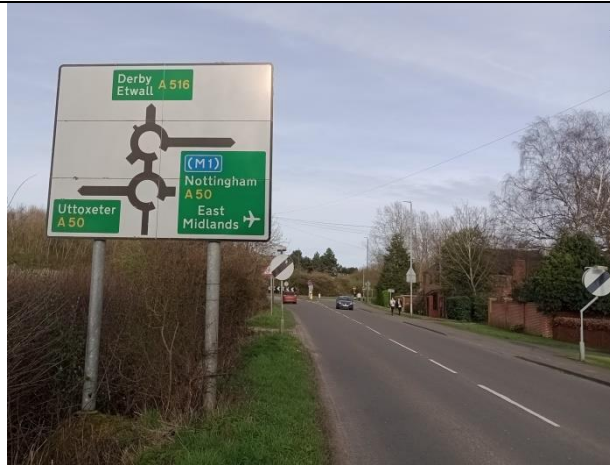
When approaching from the Hilton direction motorists could be confused by the direction sign as the righthand 'stub' aligns with the wording for the A50 to Nottingham.

Could the stub indicating the west bound exit slip be angled at 1 O'clock in the same way that the east bound slip road is shown. While the sign is compliant with Chapter 7 this change could remove any confusion.

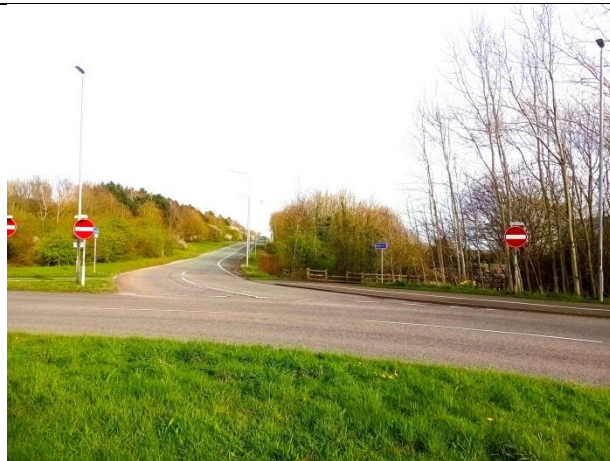
The bottom of the slip road is wide and the No Entry signs are far apart.

Could 'NO ENTRY' be painted on the road at the end of the slip road?

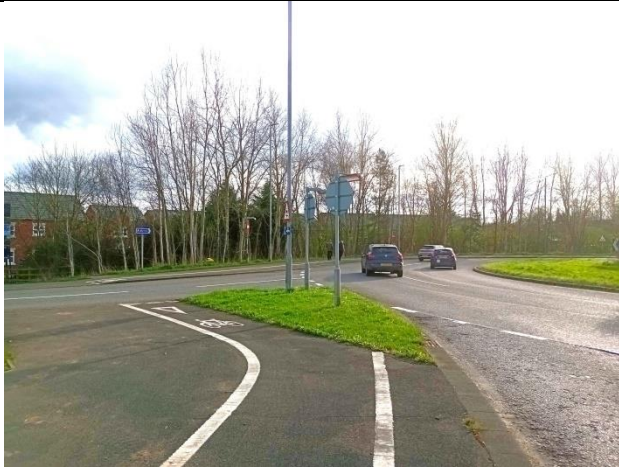
When approaching from the Derby side of the junction it is not very clear that the slip road to the left is 'No Entry' as the signs face away from the traffic.

There are 2 potential improvements that could be made. The existing signs could be turned slightly so that drivers approaching from the Derby side can see them on approach. In addition to this a 'No Left Turn' sign could be installed immediately prior to the slip road.
